**THE STREAMBANK EROSION CONTROL  
EVALUATION AND DEMONSTRATION ACT OF 1974  
SECTION 32, PUBLIC LAW 93-251**

**Appendix E - Missouri River Demonstration Projects**

# FINAL REPORT TO CONGRESS

A COMPREHENSIVE SUMMARY REPORT ON TWENTY-EIGHT  
STREAMBANK EROSION CONTROL DEMONSTRATION PROJECTS ON  
THE MISSOURI RIVER IN THE THREE REACHES: GARRISON DAM  
TO LAKE OAHE, FT. RANDALL DAM TO NIOBRARA, AND GAVINS  
POINT DAM TO PONCA

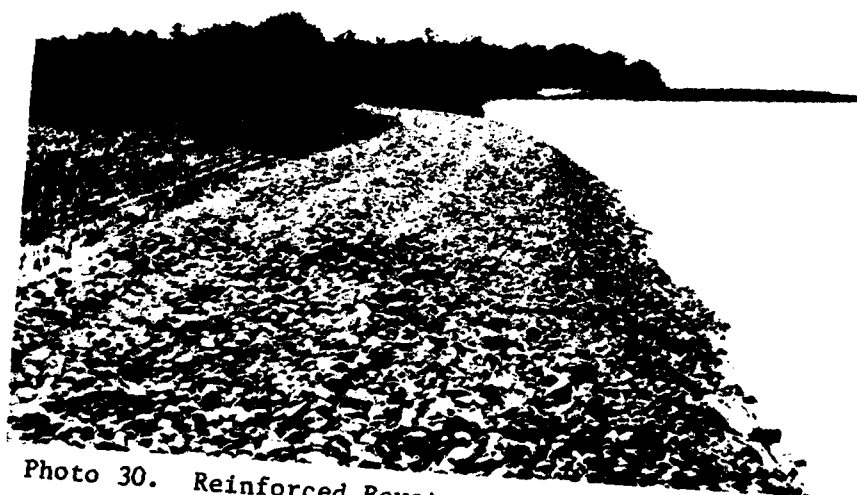
Photo 30. Reinforced Revetment 1321.8, looking downstream at Station 20+00. (Photo taken 6 August 1980)

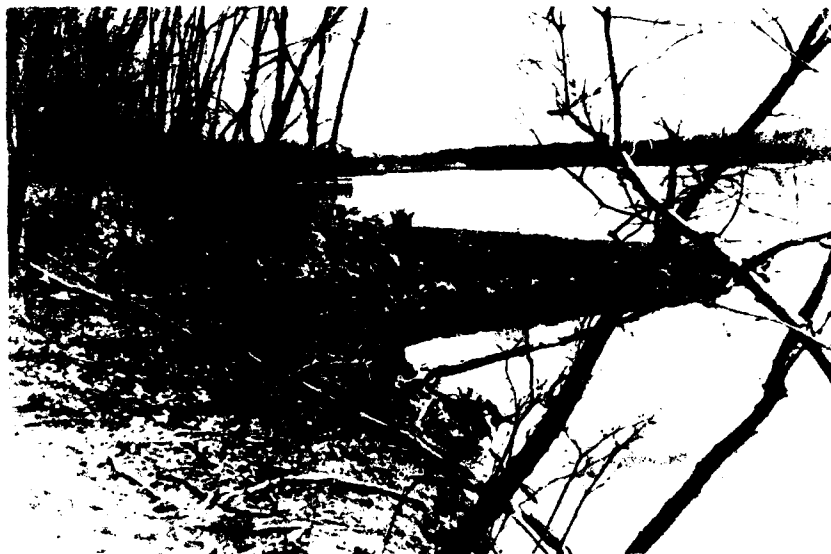
**PHOTO 5. HARDPOINT 869.24, LOOKING UPSTREAM ALONG THE MIDDLE AND DOWNSTREAM PORTION OF THE PROJECT AREA. (Photo Taken 6 April 1981)**
